# Traffic Control Review Village of Burns Lake

File No. 2341-02419-00

David Dean, PEng | Road Safety Engineer | Insurance Corporation of B.C.  
Dale Ross | Director of Public Works | Village of Burns Lake

December 2018

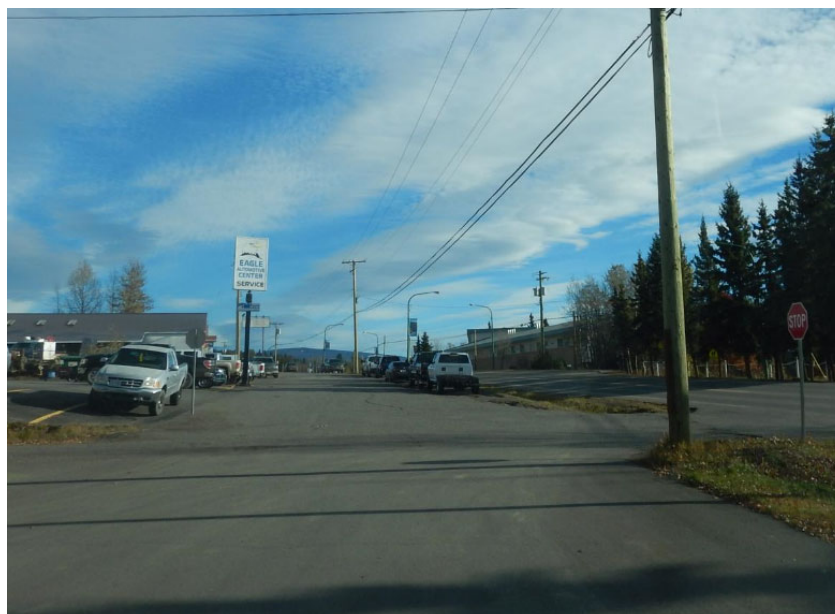
**Figure 3: New Stop Signs Warranted at Four Leg Intersection – Highway Frontage Rd (Photo 80)**

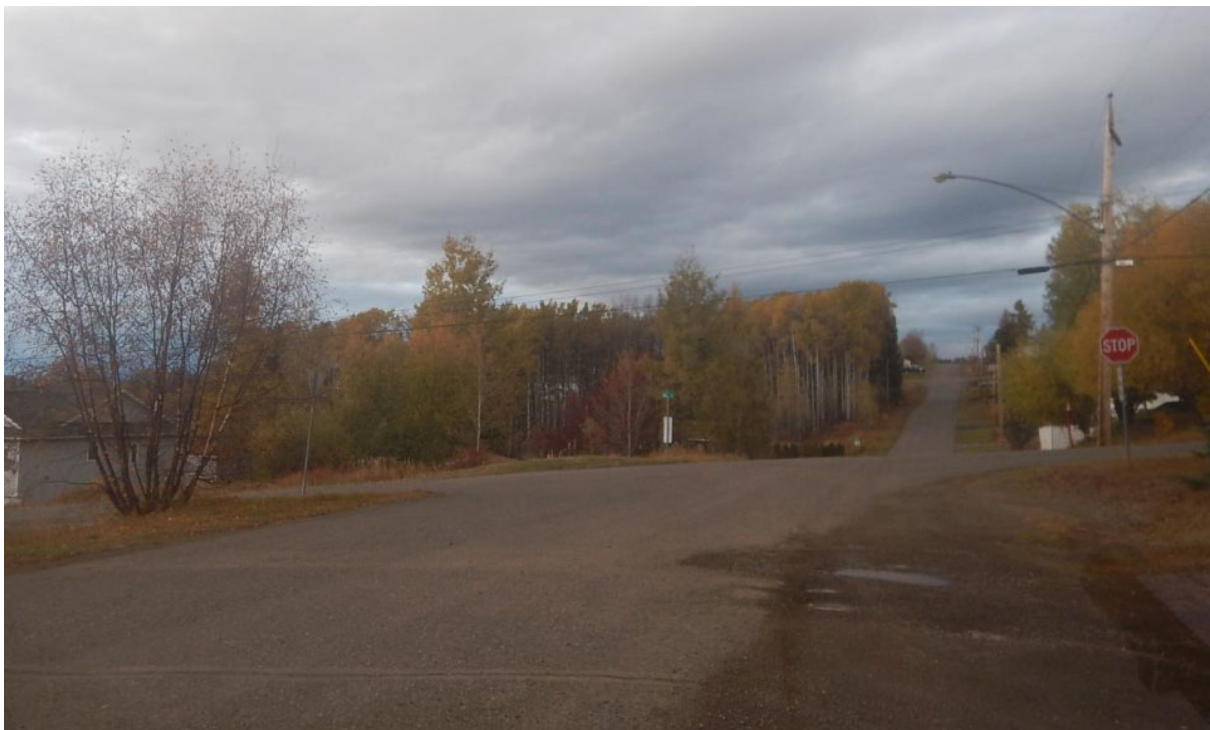
**Figure 4: Two Stop and One Yield Sign at Four-Leg Intersection – Carroll Street at Hill (Photo 158)**

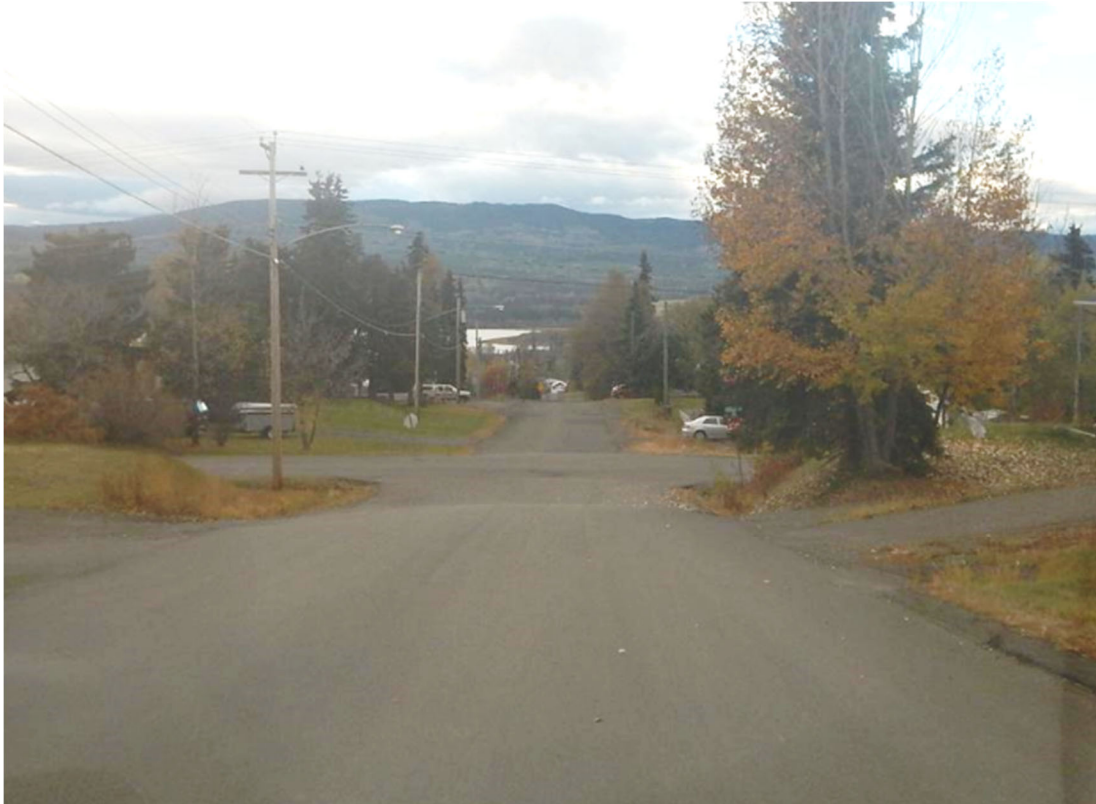
**Figure 5: Sign Obscured by Trees – Fourth Ave at Carroll Street (Photo 136)**

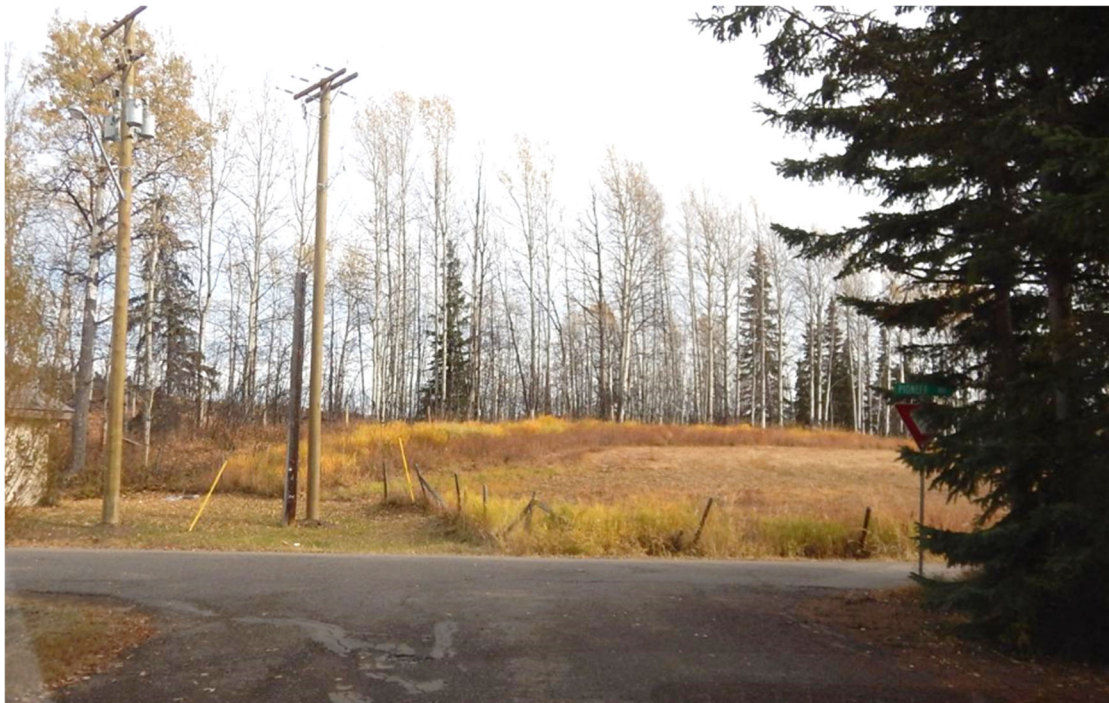
**Figure 6: Obscured Yield Sign with Insufficient Sight Distance – Bennett St at Pioneer (Photo 8)**

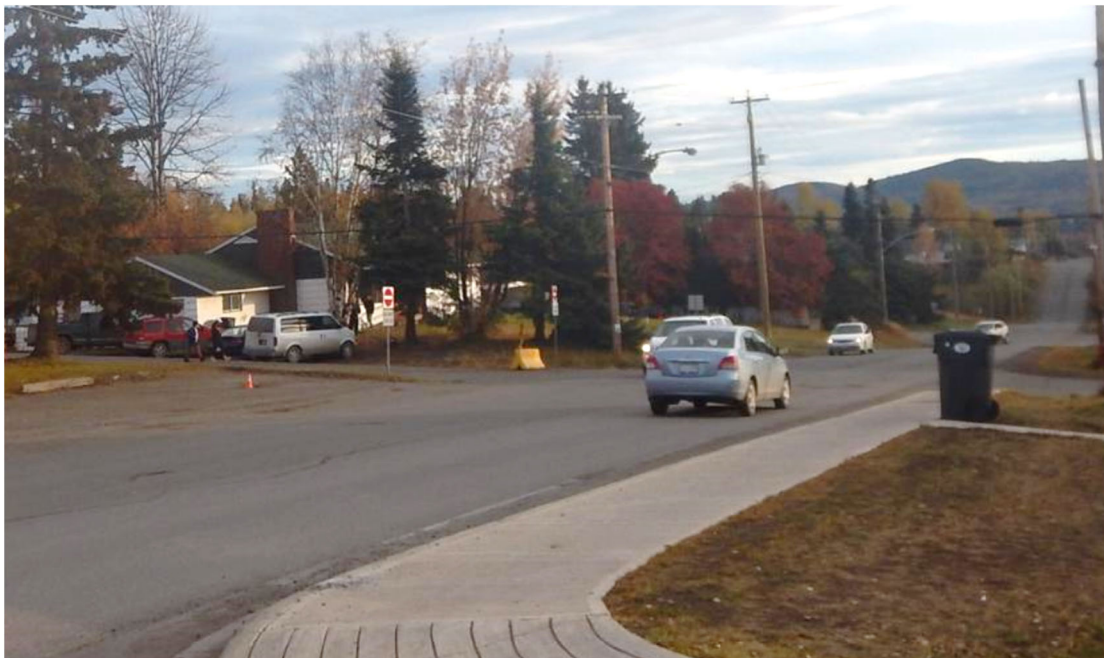
**Figure 7: No Left Turn Sign Warranted Before One Way Street – Centre Street at Ninth (Photo 130)**

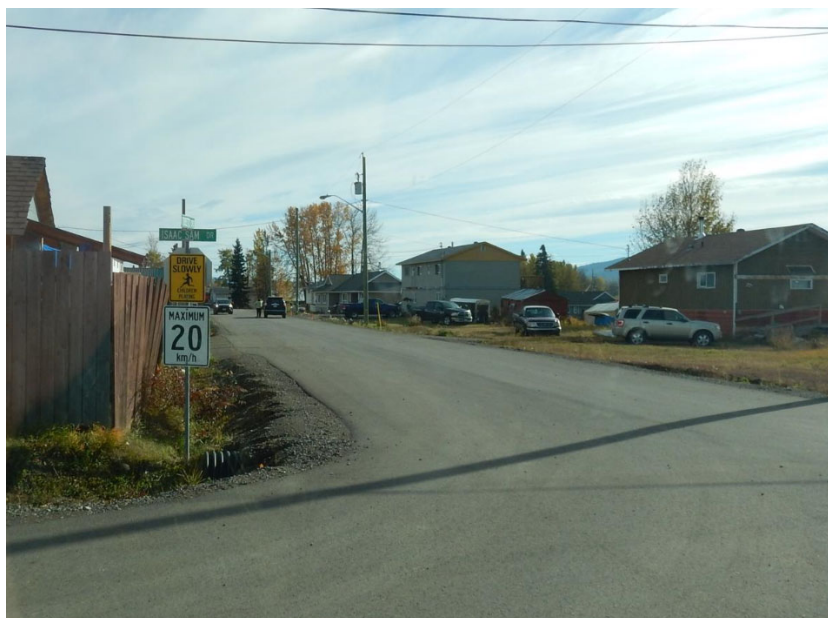
**Figure 8: 20 km/h Posted Speed in Southbound Direction Only – Tibbets Crescent (Photo 33)**

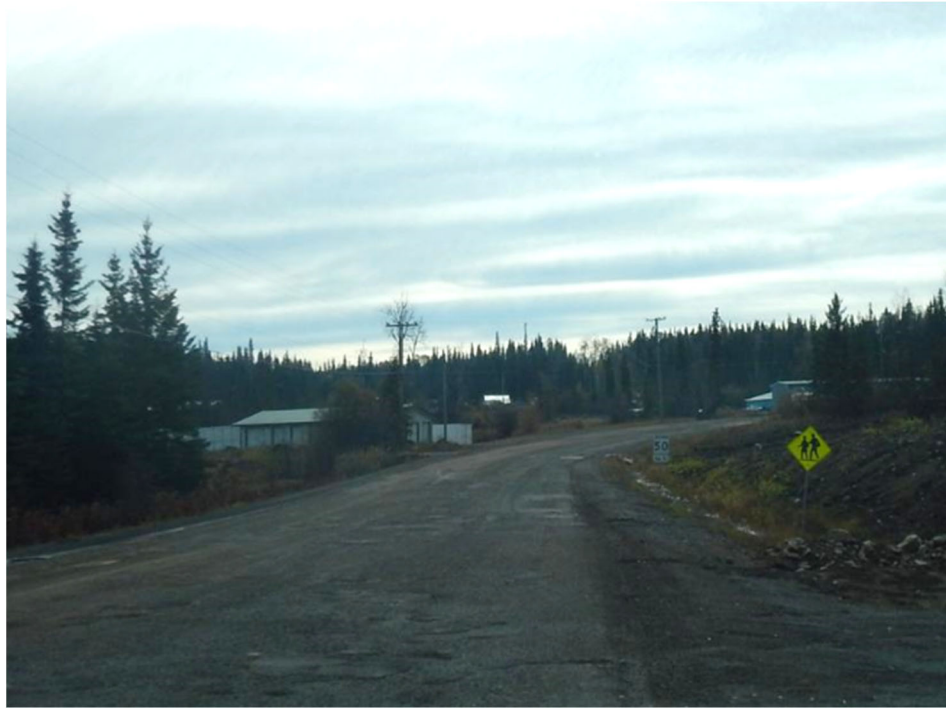
**Figure 9: No Crosswalk After Advance Warning Sign – Roumieu Drive (Photo 1)**

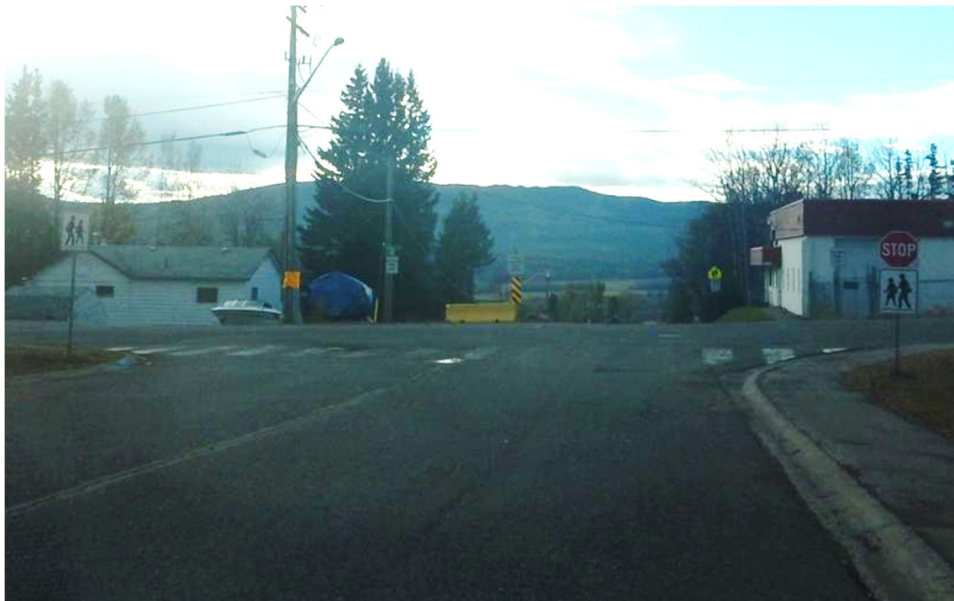
| Priority | Photo No. | Location | Comments |
|---|---|---|---|
| High | 118 | Ninth Ave at Carroll St | Replace zebra markings with parallel lines to reflect stop condition. Crosswalk signs are not warranted at a stop condition, and should be removed. |

**Figure 10: Unwarranted Signs/Markings at Stop Condition – 9<sup>th</sup> Ave at Carroll St (Photo 118)**

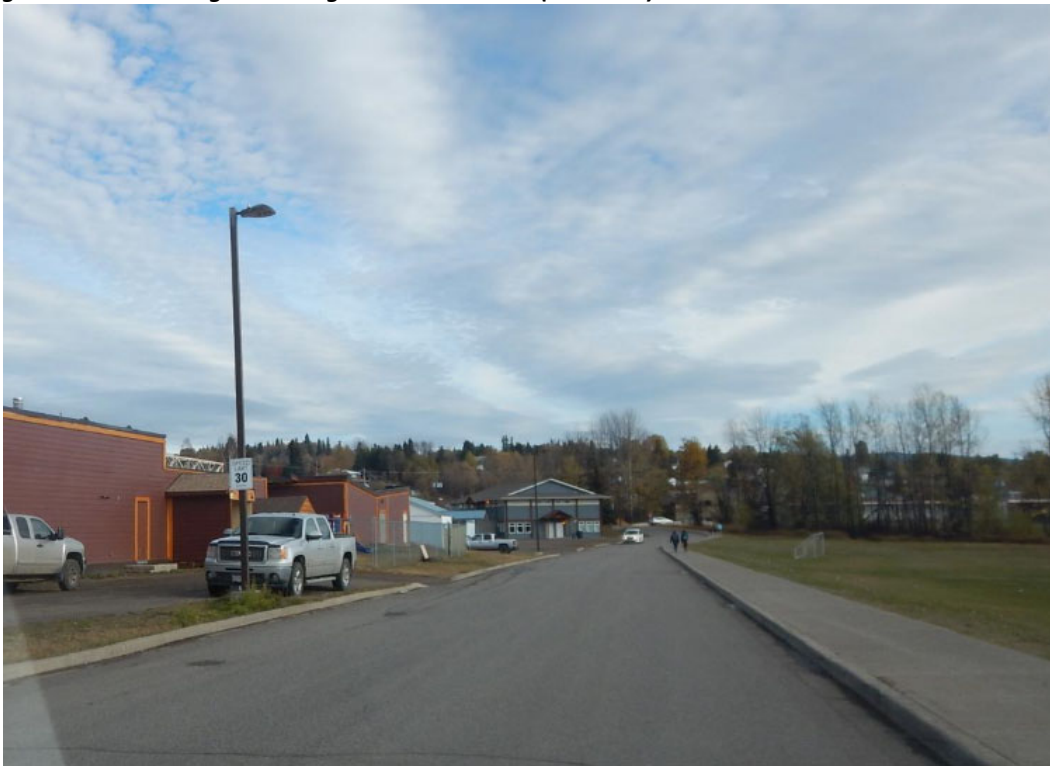
| School | Perimeter Street | TAC Score | Photo No. | Comments |
|---|---|---|---|---|
| Lakes District Secondary School | Access Road (Loop Road & Lakers Street) | 66 | 67, 68 | Warrants a School Area or School Zone. |

**Figure 12: No Existing School Signs – Lakers Street (Photo 68)**

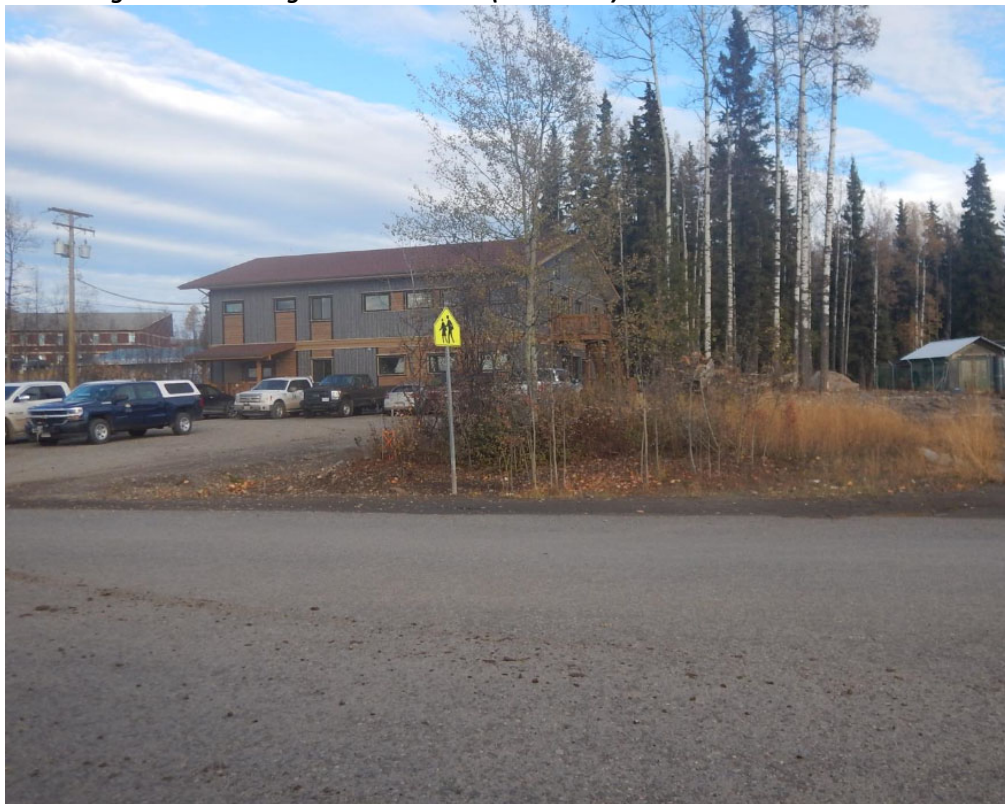
**Figure 13: Existing School Area Sign – Centre Street (Photo 101)**

To fully delimit the School Area, additional school signs should be provided as follows:

- Westbound on Sus Avenue, east of the school perimeter
- Southbound on Centre Street, north of the school perimeter

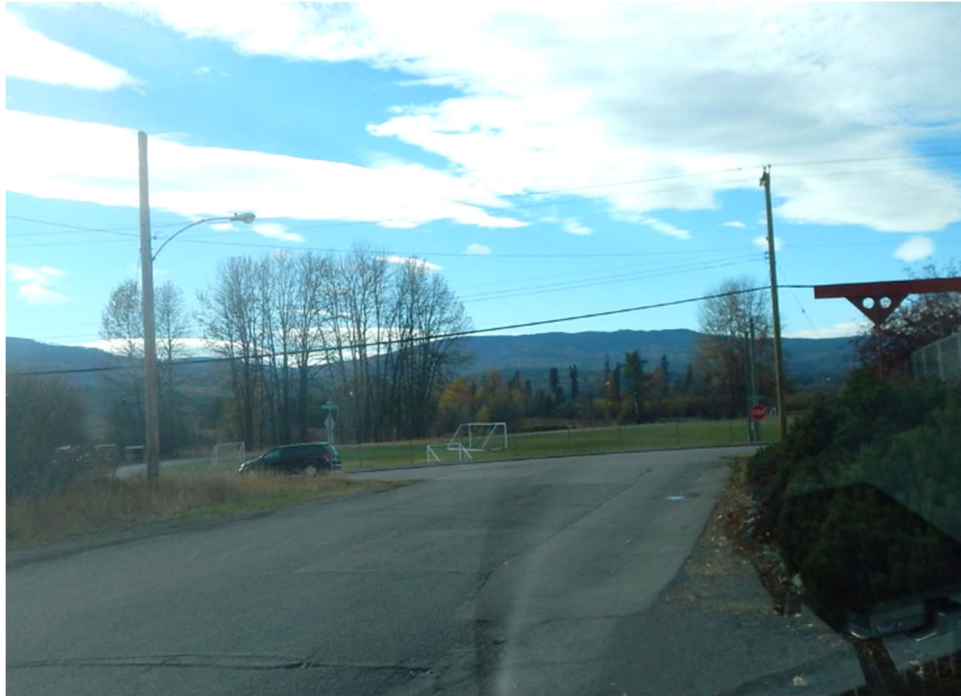
**Figure 14: Missing Playground Zone Sign – Fifth Avenue (Photo 65)**

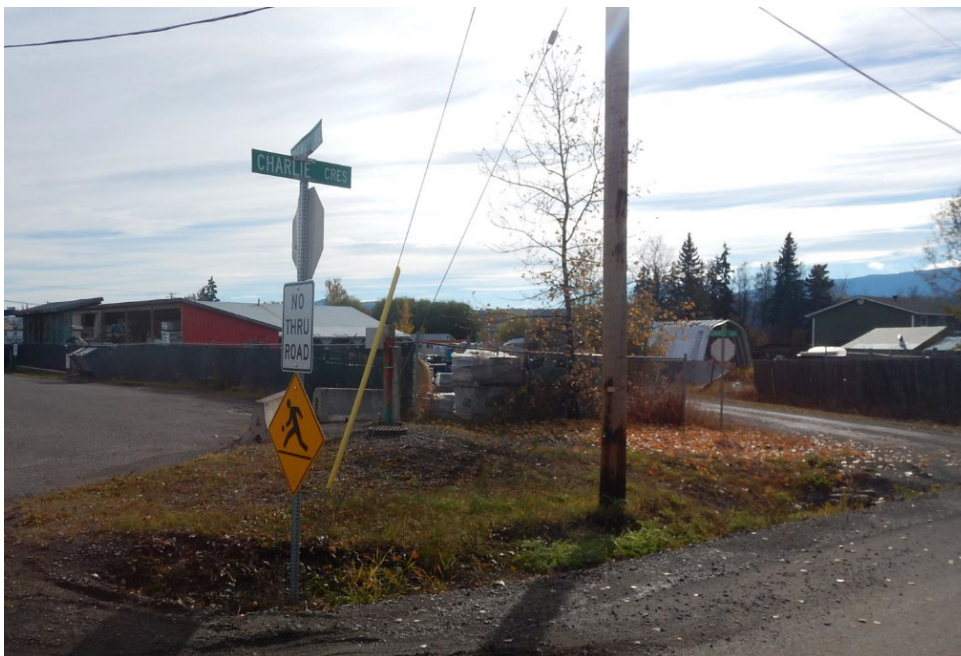
| Playground | Perimeter Road | TAC Score | Priority | Photo Nos. | Comments |
|---|---|---|---|---|---|
| Tot Lot | Tibbetts Crescent | 90 | High | 28, 34, 35 | 30 km/h Playground Zone warranted. Existing sign on Charlie Crescent should be relocated to Tibbetts Crescent, and a new sign added for the opposing (NB) traffic. Also add 30 km/h tabs to both signs. |

**Figure 15: Need for Playground Sign Relocation – Charlie Crescent (Photo 28)**

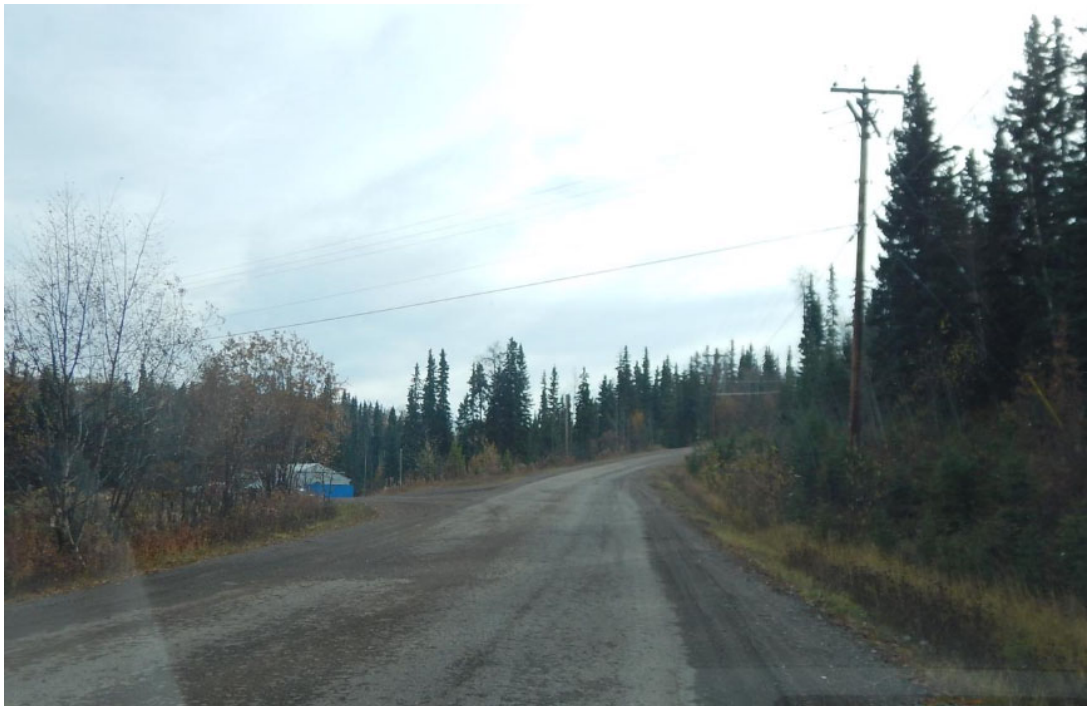
| Priority | Photo No. | Location | Comments |
|---|---|---|---|
| High | 3 | Roumieu Drive | Sharp curve on steep gravel hill. Advance curve warning signs may be warranted in both directions. The curve warning signs can be complemented with curve chevrons, if desired. |

**Figure 16: Potential Warrant for Advance Curve Warning Signage – Roumieu Drive (Photo 3)**

Before curve warning signs are installed or adjusted, the warrants and design of the signage and advisory speeds should be confirmed based on engineering curve testing (see Section 6).

1. **Curve Testing:** As noted in Section 3.8, the curve on Roumieu Drive is significant, and located on a steep hill. The curve could be tested to confirm the necessary signing and advisory speed tabs. Curve testing involves driving the curves at different speeds using a ball-bank indicator to measure the centrifugal forces. The test results indicate what speeds are appropriate for the curve, and what signing is required.

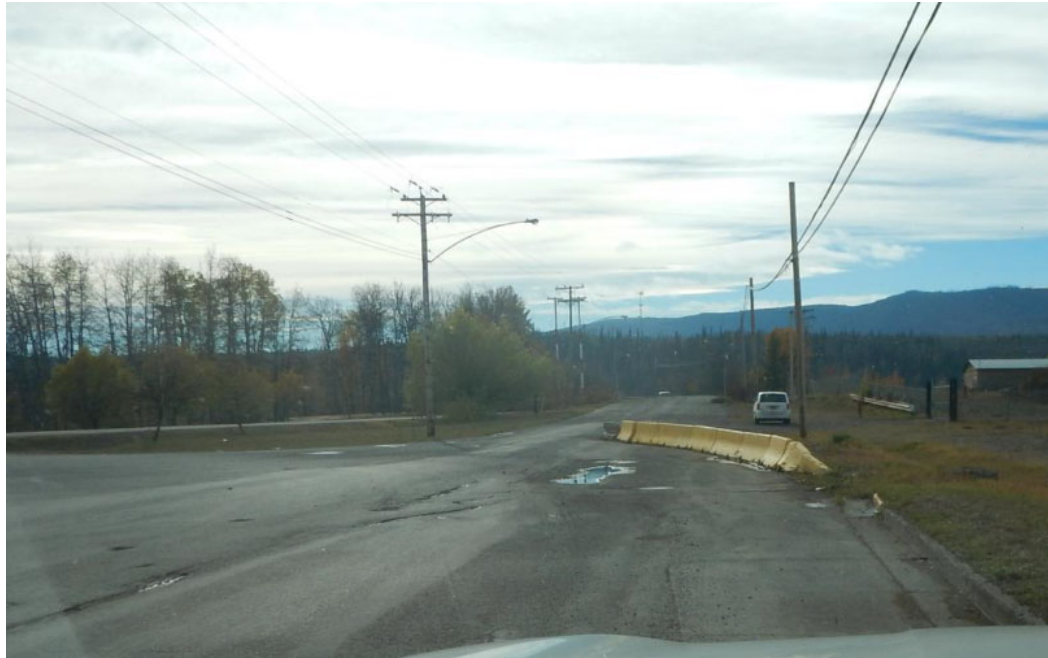
**Figure 17: Object Markers Warranted on Roadside Barrier – Francois Lake Road (Photo 18)**

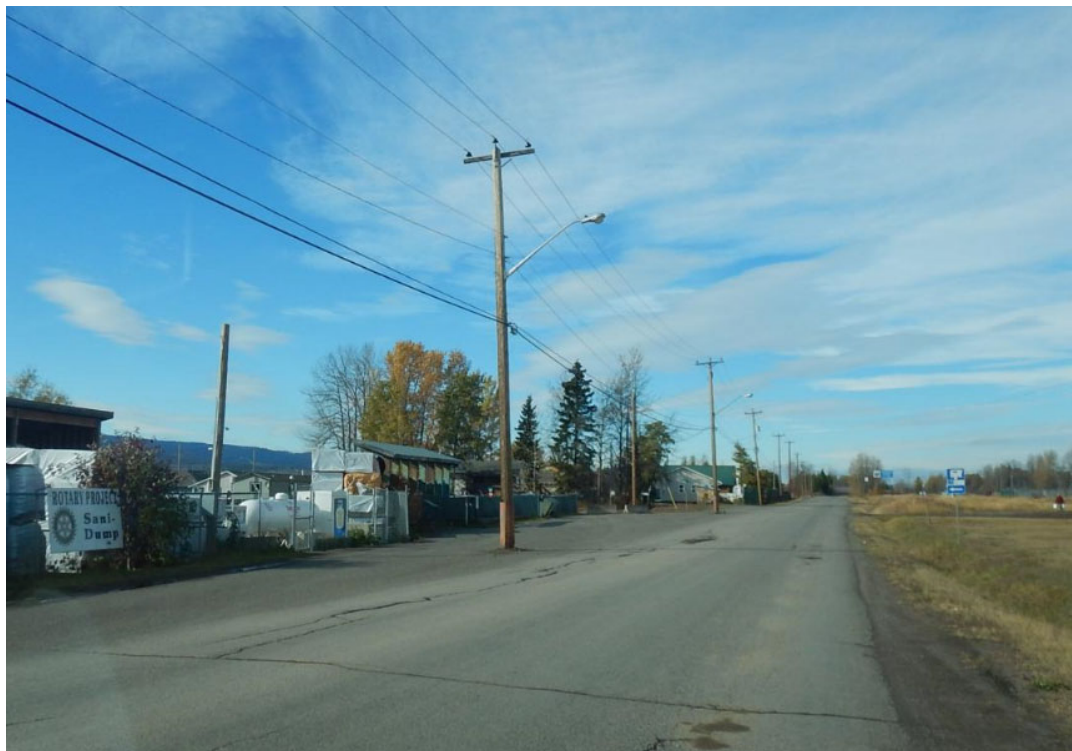
**Figure 18: Hydro Poles Need Better Visibility in Road Area – Railway Avenue (Photo 38)**

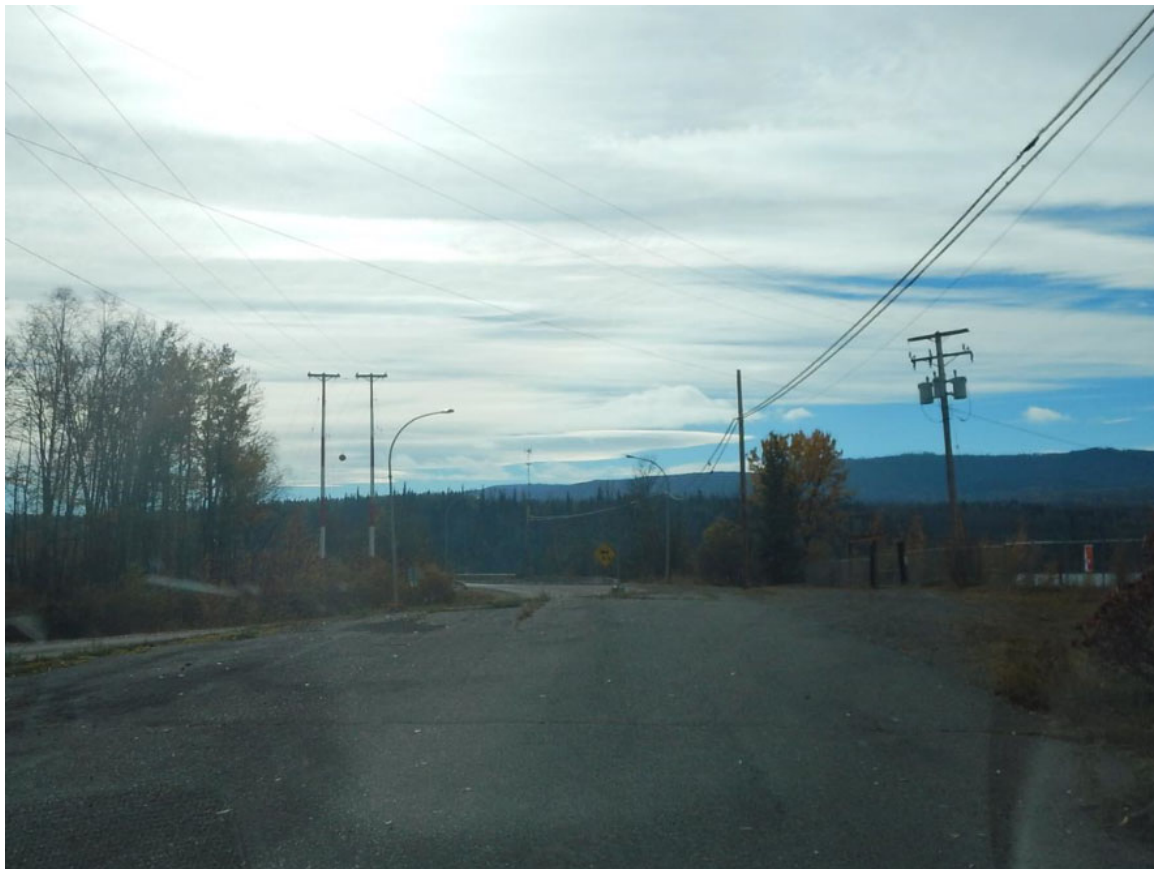
**Figure 19: New Checkerboard Warranted – Francois Lake Drive (old section; Photo 19)**

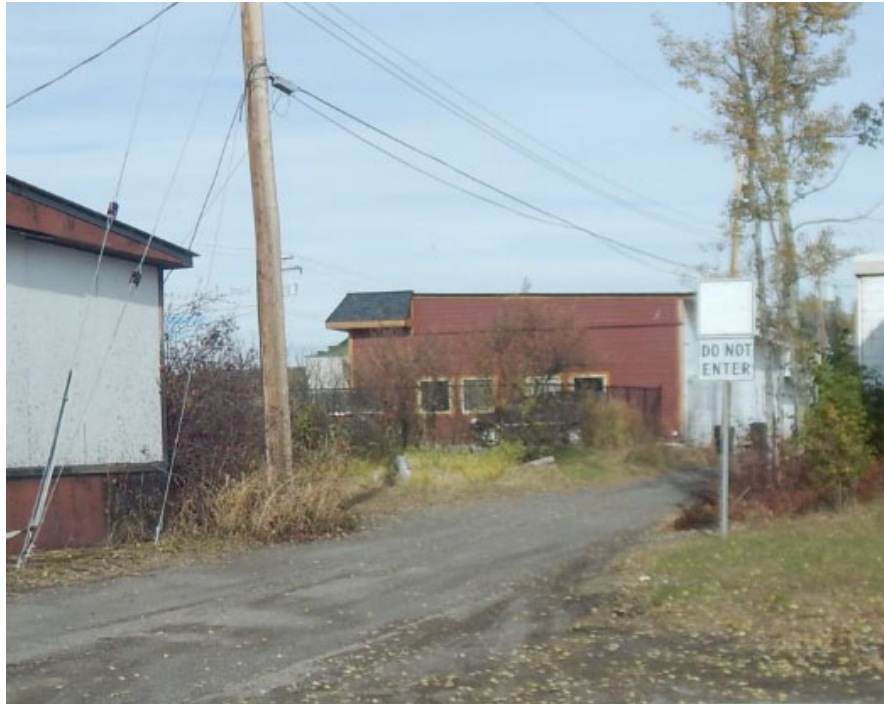
**Figure 21: Faded Do Not Enter Sign – Francois Lake Drive Lane (Photo 17)**

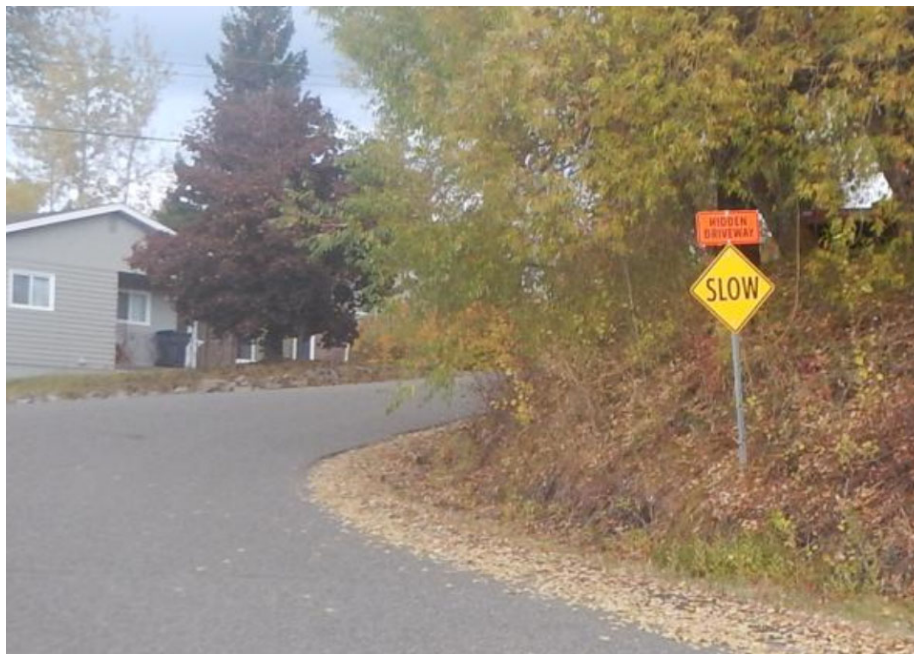
| Priority | Photo No. | Location | Comments |
|---|---|---|---|
| Low | 160 | Hill Street at curve | Hidden Driveway tab should be yellow to reflect a permanent condition. |

**Figure 22: Orange Hidden Driveway Sign – Hill Street at Curve (Photo 160)**

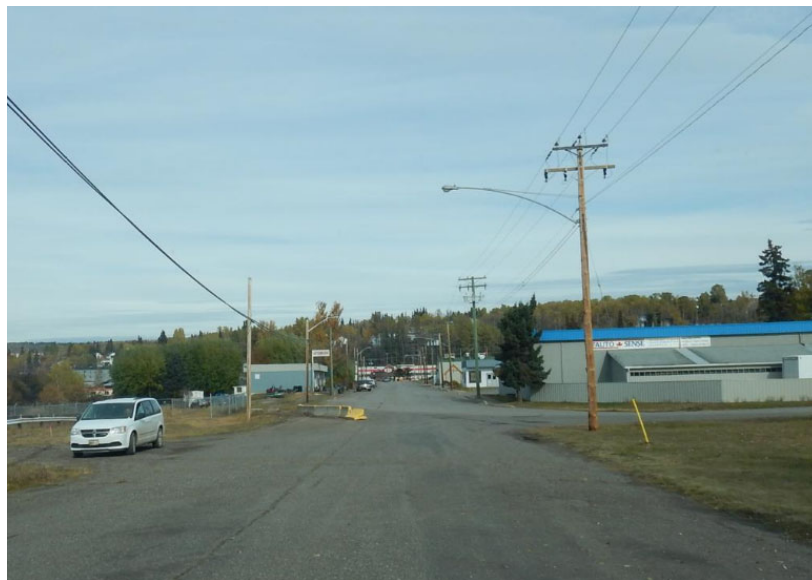
**Figure 23: Warrant for New Centreline – Francois Lake Drive at Curve (Photo 20)**

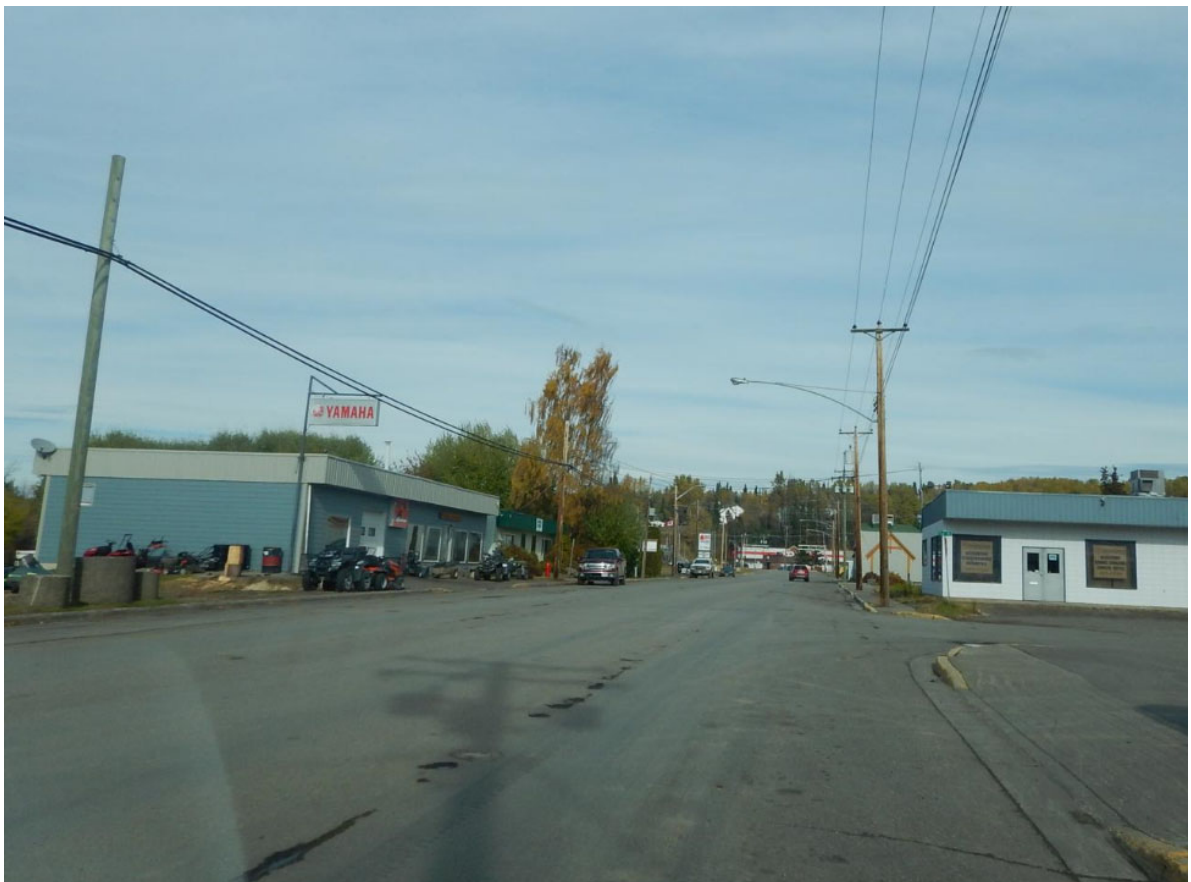
Most roads in Burns Lake are too narrow for shoulderlines. As noted in Section 4.1, Francois Lake Drive appears to have sufficient width for shoulderlines. This may require additional study to determine how to best dedicate the available widths between traffic lanes, shoulder/bike lanes, and on-street parking (see Section 6).

**Figure 24: Potential for Shoulder Lines – Francois Lake Drive (Photo 23)**

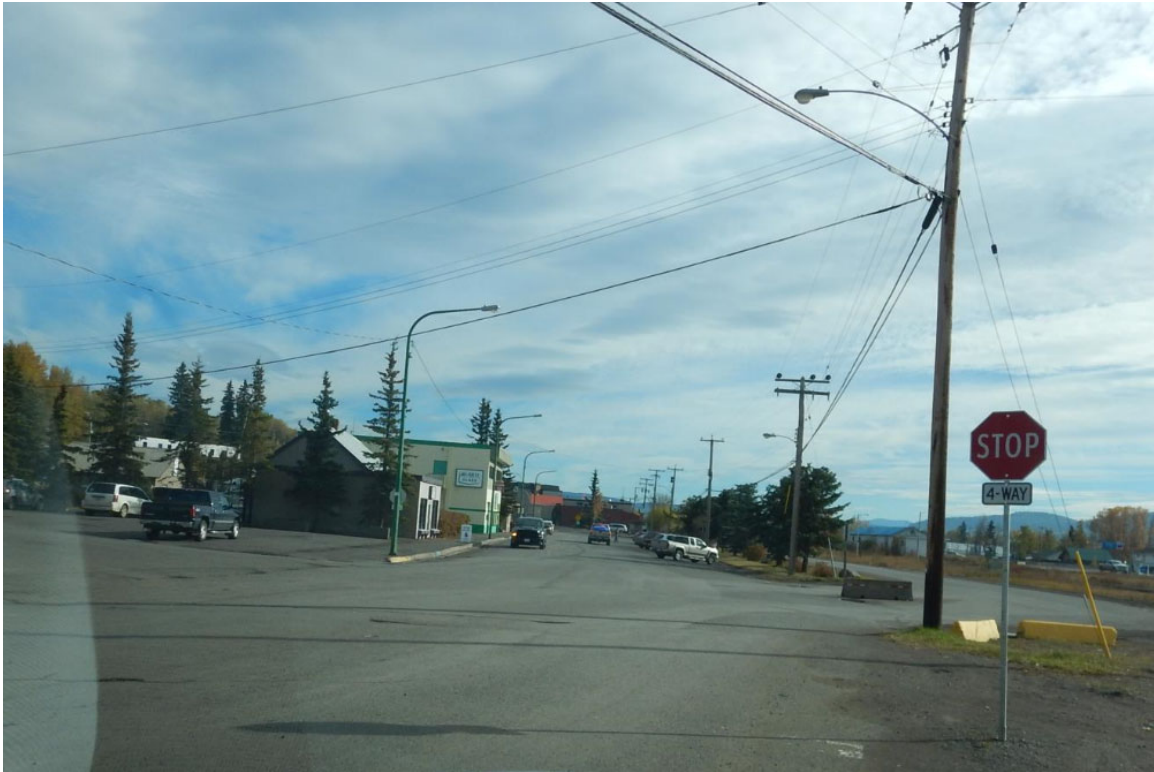
**Figure 25: Stop Lines Warranted at Four Way Stop – Government Street at Third (Photo 59)**

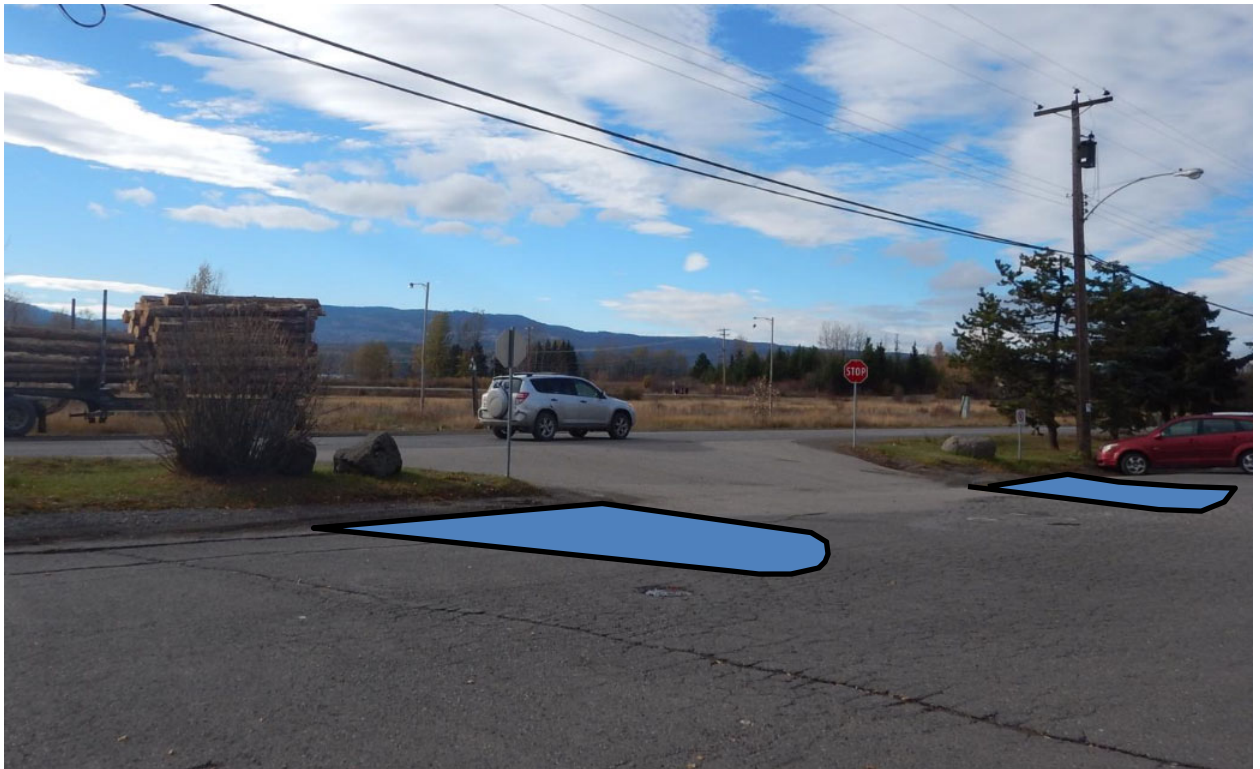
The existing access on Government Street to the area around the post office has a short throat distance (i.e. the distance between the edge of the road and the beginning of the parking lot area, in which traffic is expected to queue). This could create issues with traffic/parking conflicts and guidance, especially under heavy traffic conditions.

**Figure 27: Short Access Throat – Government Street at Post Office (Photo 60)**

With the angle parking configuration adjacent to the access, short islands could be added to each side of the access to increase the throat length, and better define/protect the parking area (see Figure 27).
