# Traffic Control Review Village of Burns Lake

File No. 2341-02419-00

David Dean, PEng | Road Safety Engineer | Insurance Corporation of B.C.  
Dale Ross | Director of Public Works | Village of Burns Lake

December 2018

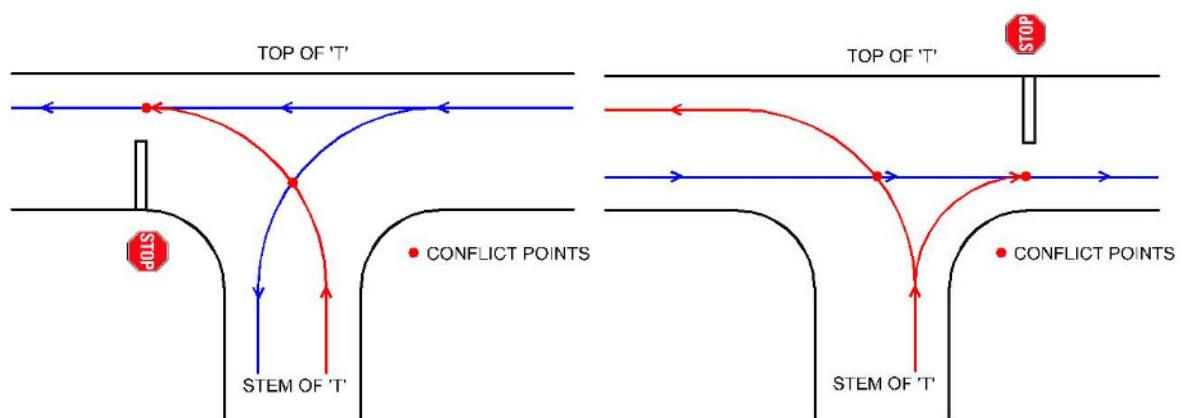
**Figure 1: Traffic Conflicts When Stop Condition is on Top of "T" Intersection**

At "T" intersections, the stop condition is ideally applied to the stem of the "T" (according to the Transportation Association of Canada). This is more intuitive to drivers, and avoids conflicts between free-flow traffic traveling across the top of the "T" and free-flow traffic turning from the stem of the "T" (see Figure 1). Therefore, even stop signs for traffic coming from short cul-de-sacs are recommended, but are considered lower priorities than those on higher class roads.

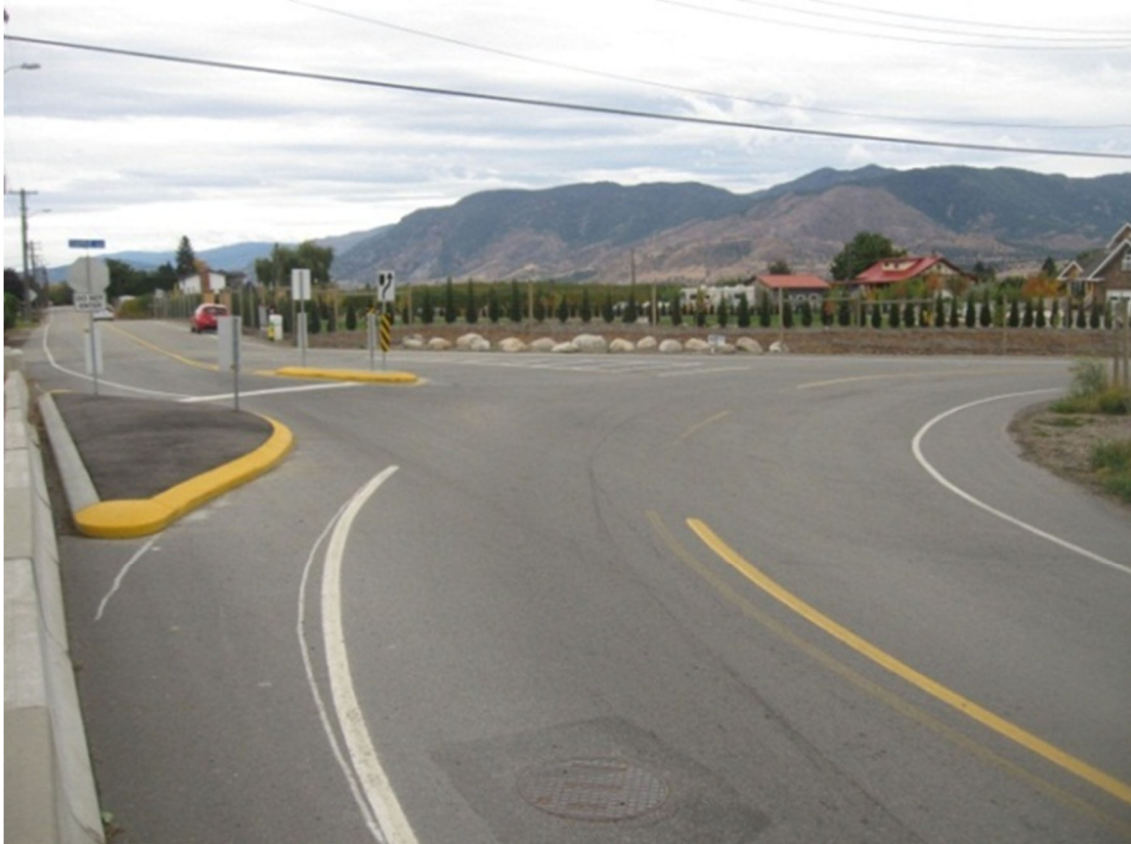
**Figure 2: Example Upgrade to Give Priority to Turning Movements at a “T” Intersection**

If the predominant movements through a “T” intersection are turning, the intersection can be redesigned to favour the turning movement (see example, Figure 2) if desired. This involves minor geometric improvements, and the use of curve signing and centreline markings.

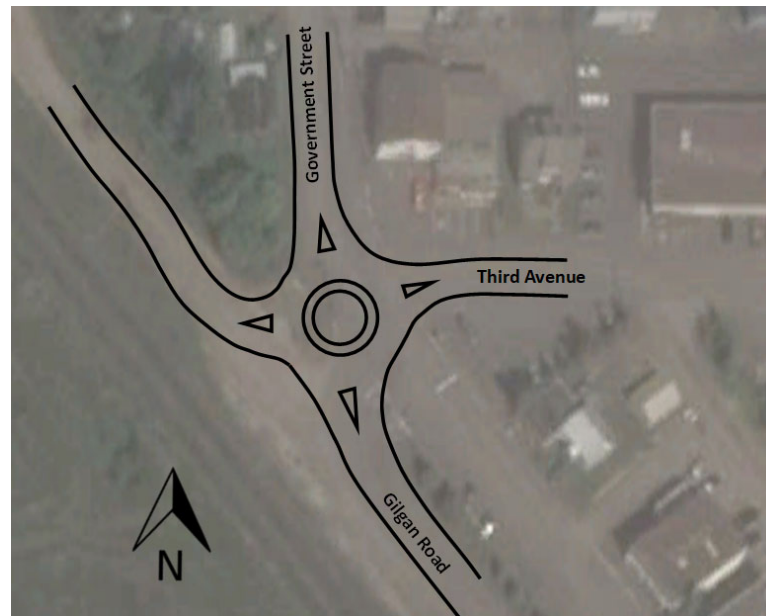
**Figure 26: Potential Roundabout Concept – Government Street at Third Avenue**

Additional study is required to identify short and long term solutions at this intersection (see Section 6).
